Fleet Readiness Center Southwest

Production Cold Spray Repairs for NAVAIR

Presenter: Matthew Minnick, Materials Engineer, Code 43460

Date: May 23, 2018

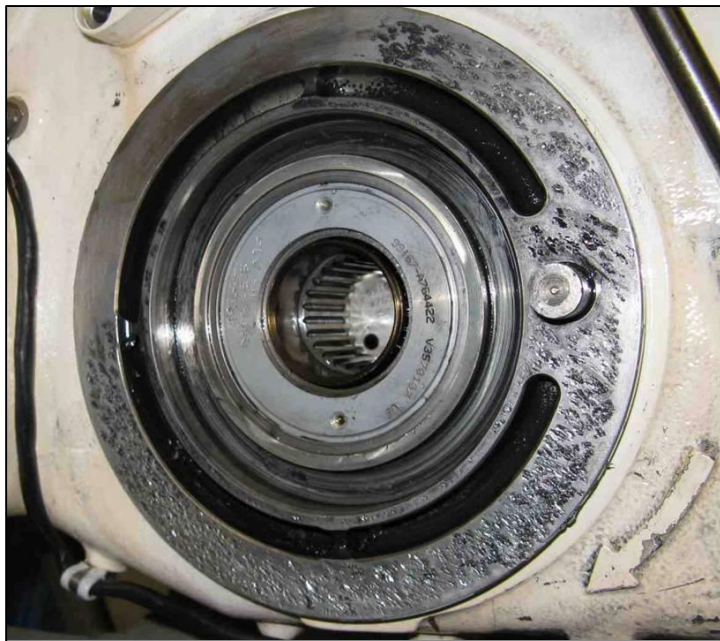
Repair: Fretting damage to sealing surface

Part Material: Aluminum A357 casting

Fretting Damage

Repair Type: Dimensional restoration

System: Inovati KM-PCS

Powder: 7075 Aluminum with Nickel

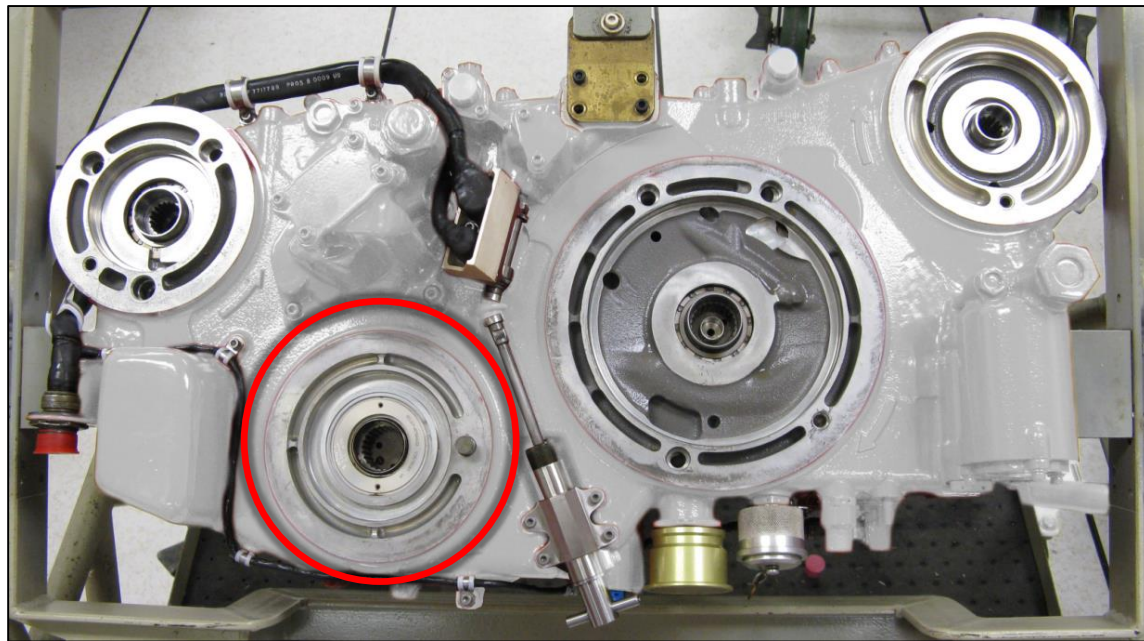
After Repair

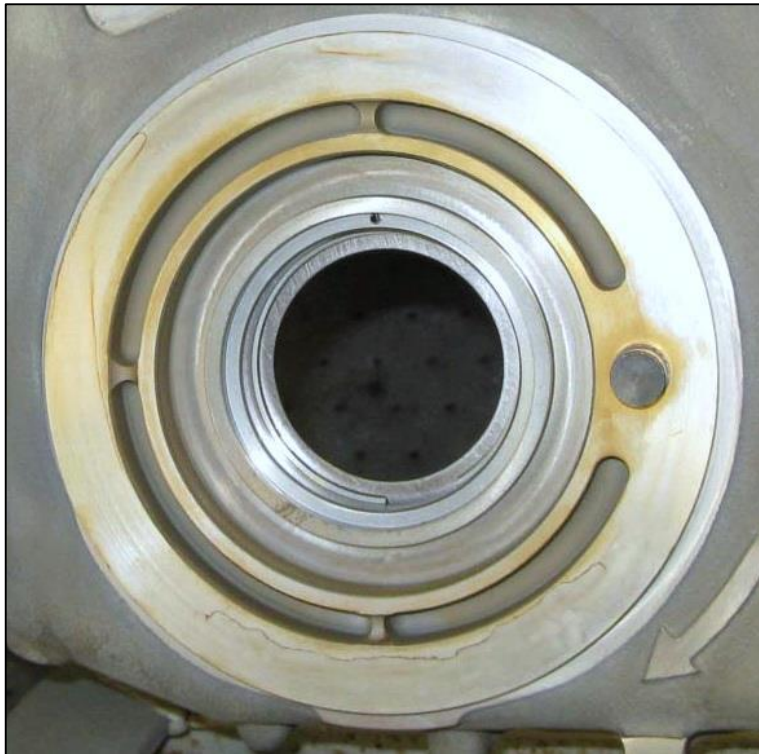
May 2011

Cold Spray Repaired

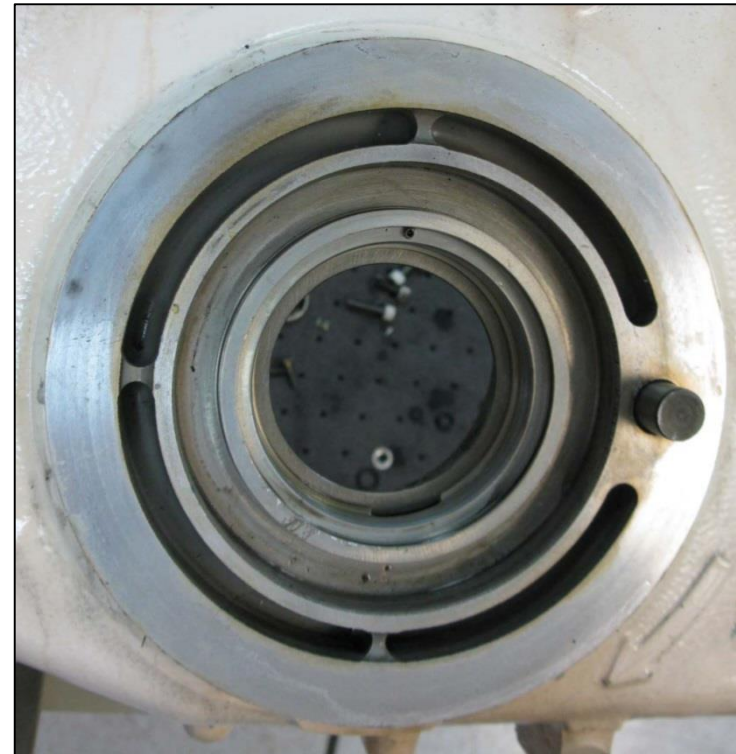
November 2016

Inspection at 1,748 Flight Hours

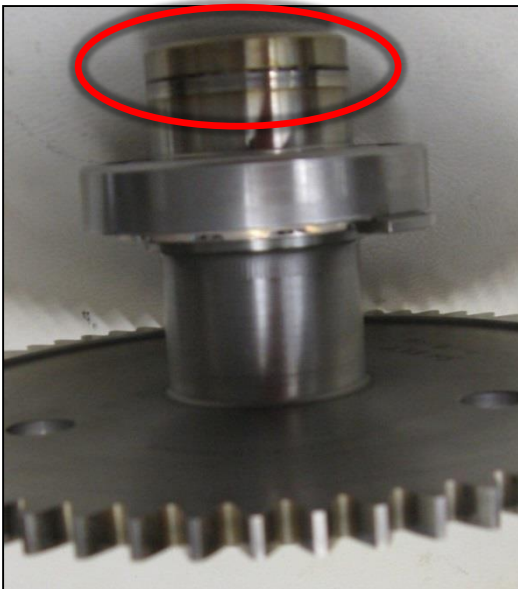
Repair: Wear damage to sealing surface

Part Material: AMS 6265 steel

Damaged Seal Surface

Repair Type: Dimensional restoration

System: Inovati KM-PCS

Powder: Tungsten Carbide Cobalt

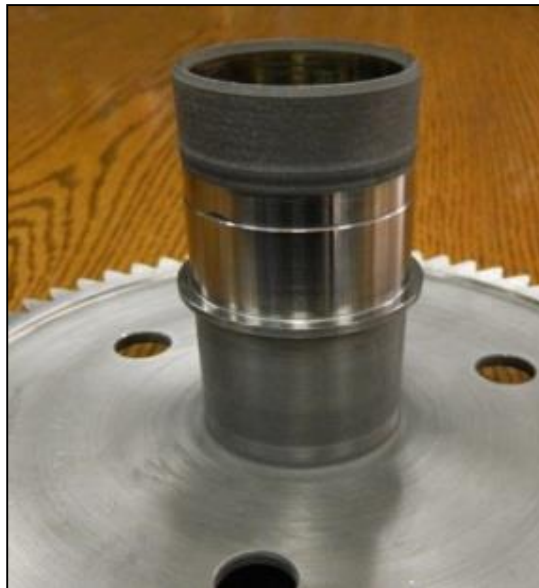
After Cold Spray

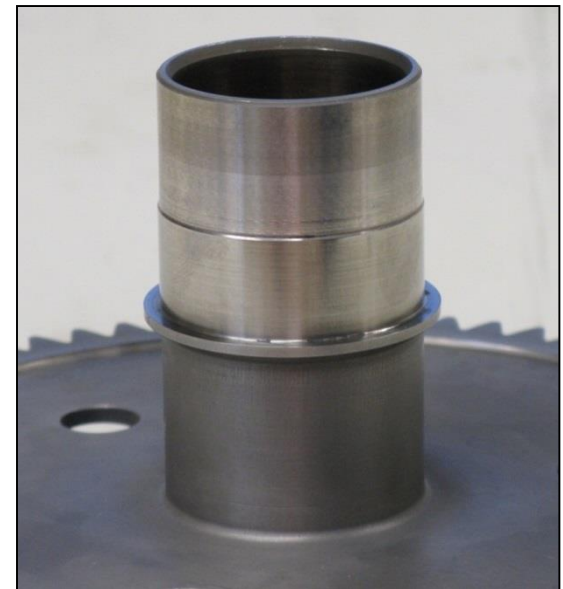
Restored Seal Surface

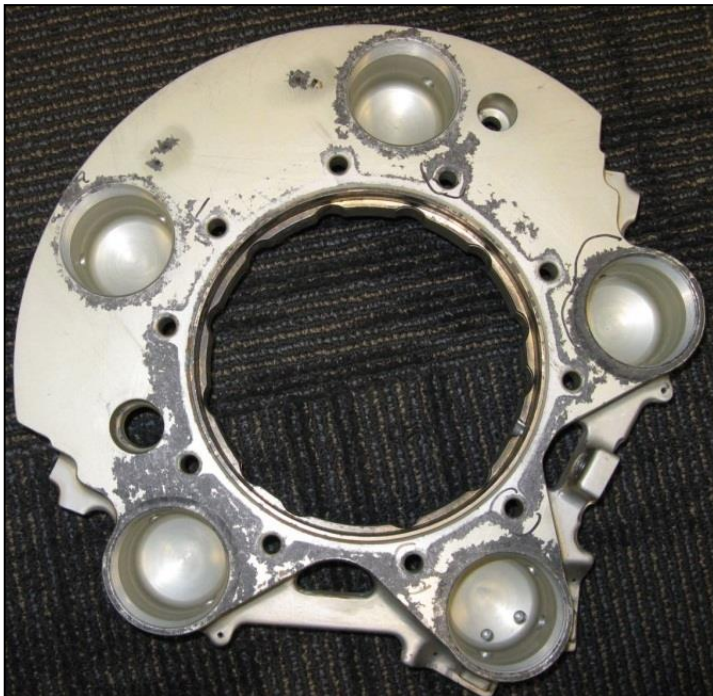
Repair: Corrosion damage

Part Material: Aluminum 2014-T61

Corrosion Damage

Repair Type: Dimensional restoration

System: Inovati KM-PCS

Powder: Aluminum with Chrome

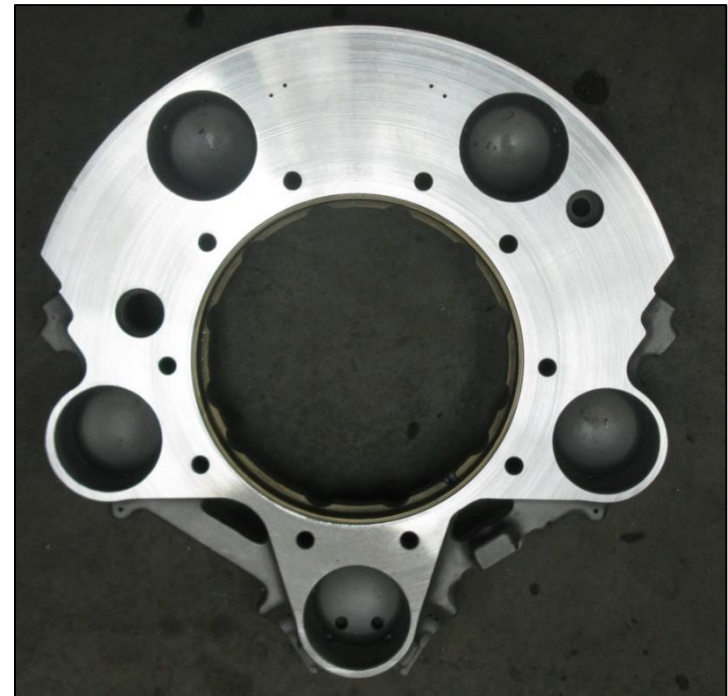
After Repair

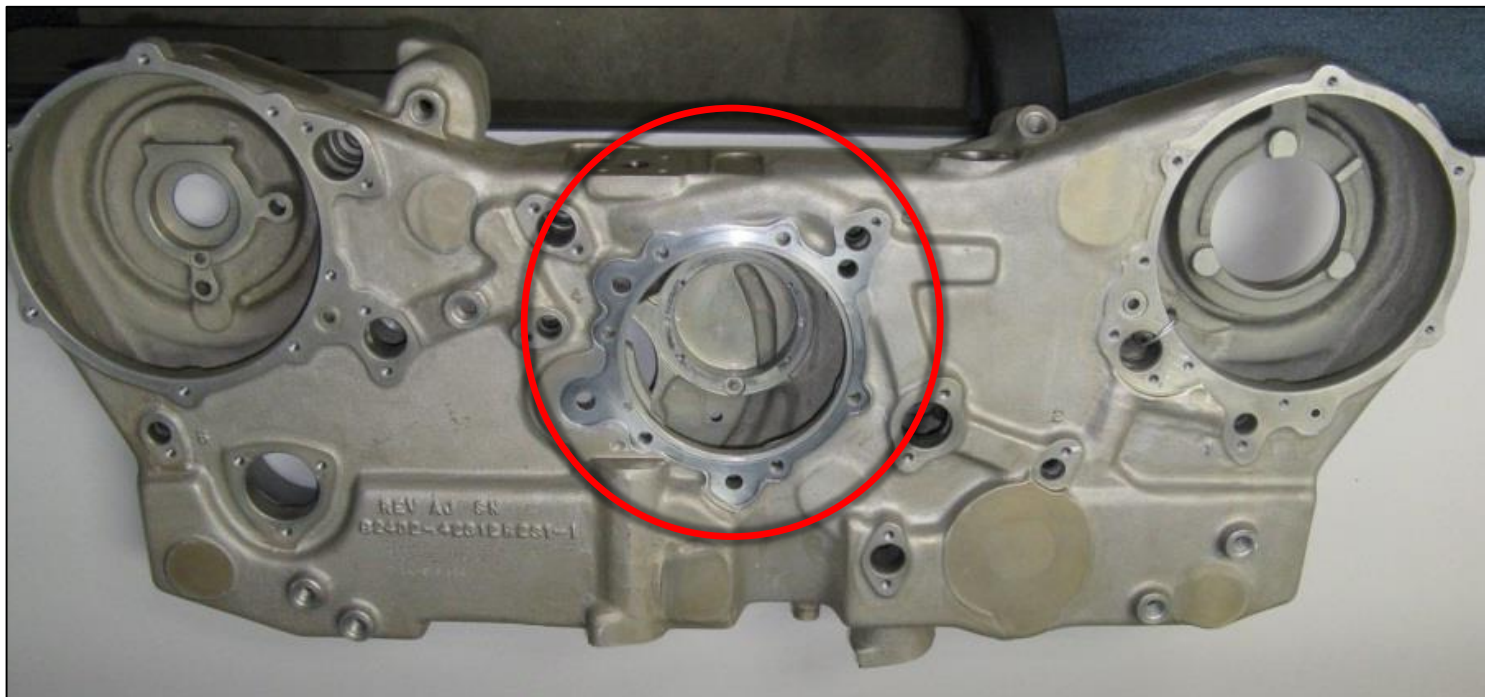
AMAD Housing PTS Flange

Repair: Fretting damage

Part Material: Aluminum A356 casting

After Repair

Repair Type: Dimensional restoration

System: Inovati KM-PCS

Powder: 7075 Aluminum with Nickel

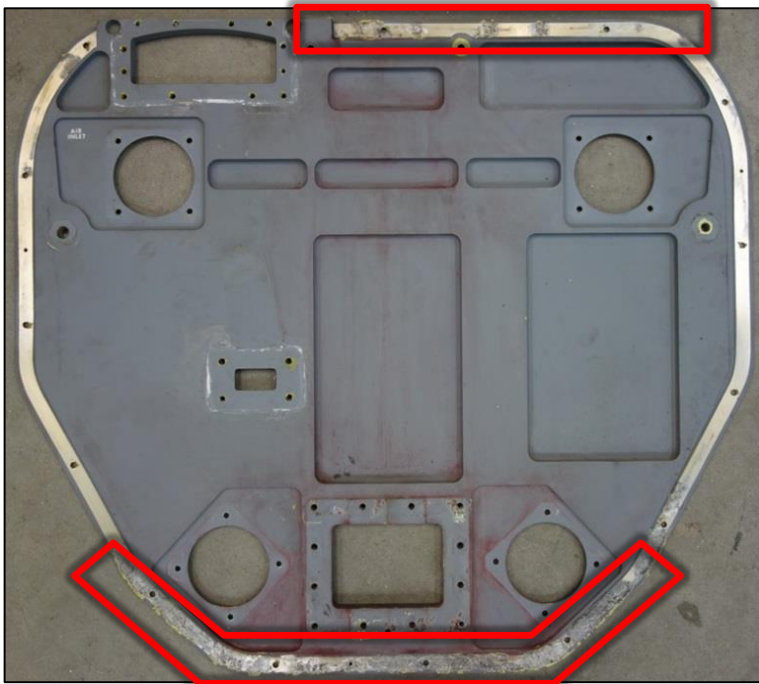
APG-73 Radar Rack Assembly

Repair: Corrosion damage

Part Material: Aluminum 7075-T7351

Corrosion Damage

Repair Type: Dimensional restoration

System: Inovati KM-PCS

Powder: Aluminum with Chrome

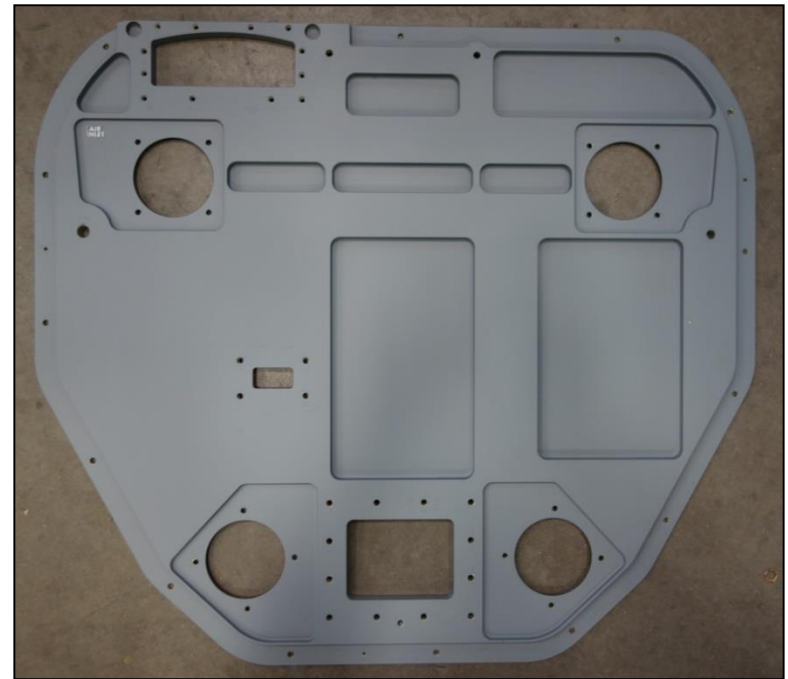
After Repair

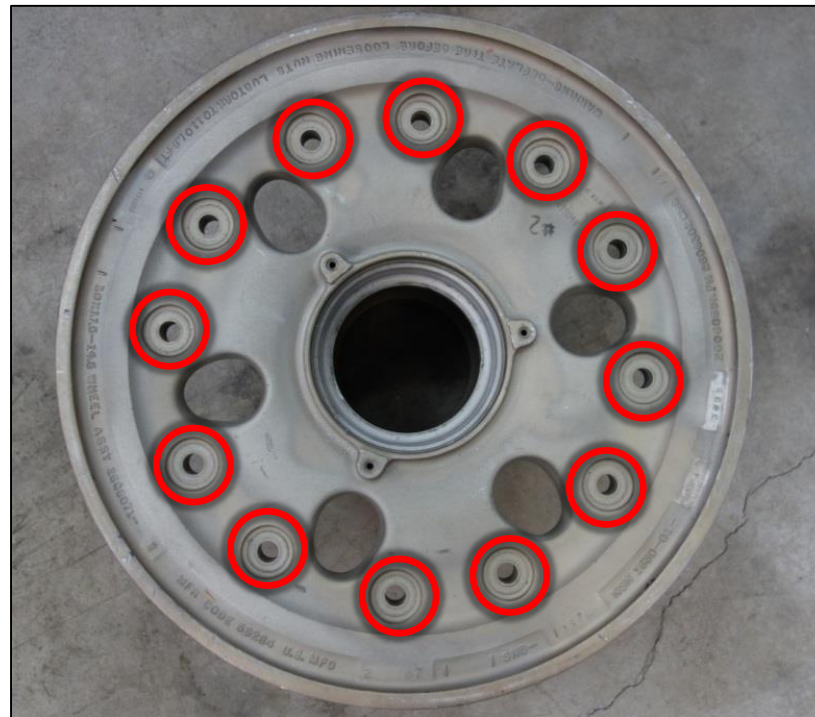
Outboard MLG Wheel Bolt Spot Face

Repair: Mechanical/corrosion damage

Part Material: Aluminum 2014

Before Repair

Repair Type: Dimensional restoration

System: Inovati KM-PCS

Powder: Aluminum with Chrome

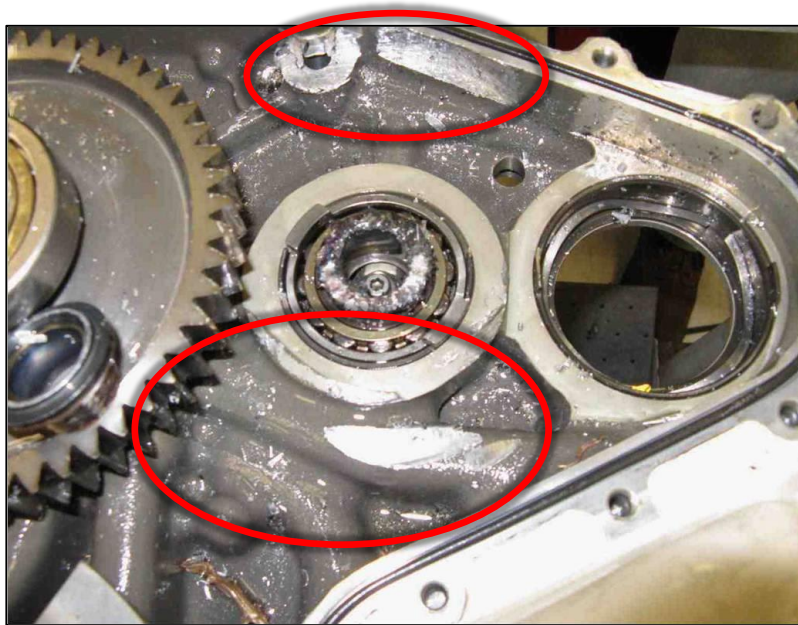
Repair: Mechanical damage

Part Material: Aluminum A357 casting

Mechanical Damage

Repair Type: Dimensional restoration

System: Inovati KM-PCS

Powder: Aluminum with Chrome

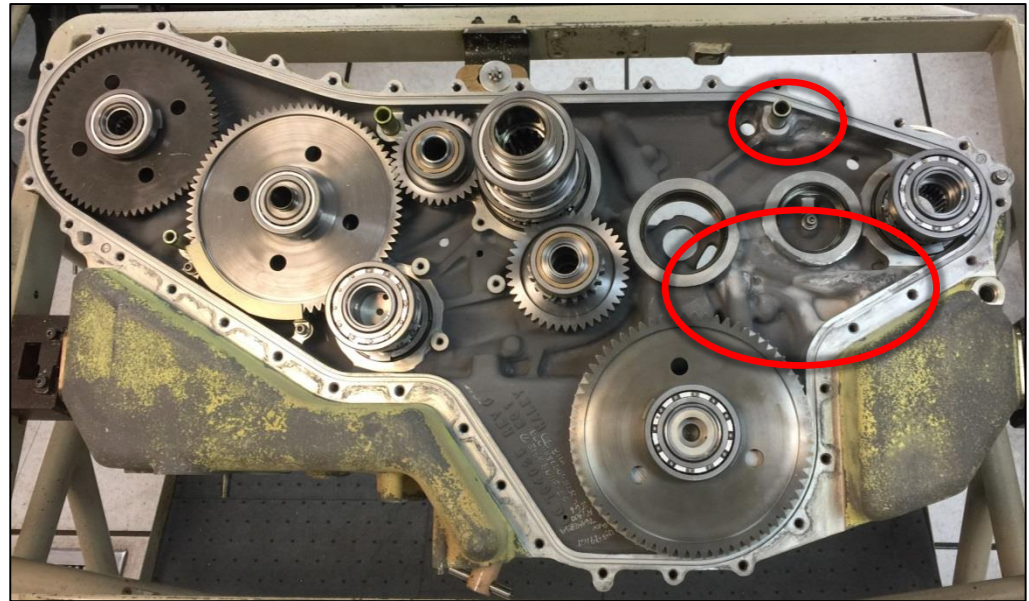
After Repair
